# Technical News

**Solutions to prevent overheating  
of critical switchgear**

**Written By George Matta**  
Product Marketing Manager -  
Switchboard Protection - NHP  
**and Nicholas Burley**  
Business Manager -  
Power Distribution - NHP

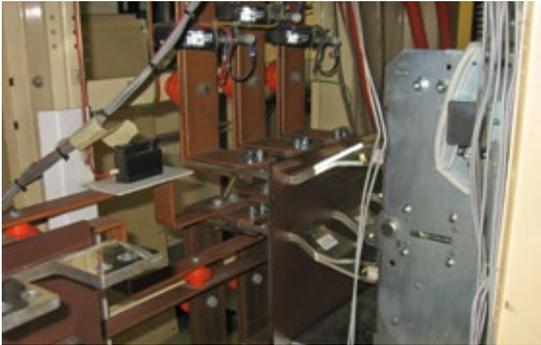
Figure 1 – Rear copper connections to the ACB chassis

If any of the copper connections onto the main ACB terminals (Figure 1) are not at the correct torque, this can lead to a potential hot spot. Equipment close to machinery which have reasonable vibration such as generators, pumps, motors or compressors can loosen the copper to copper making surface, potentially leading to a situation where over time an over-temperature could result.

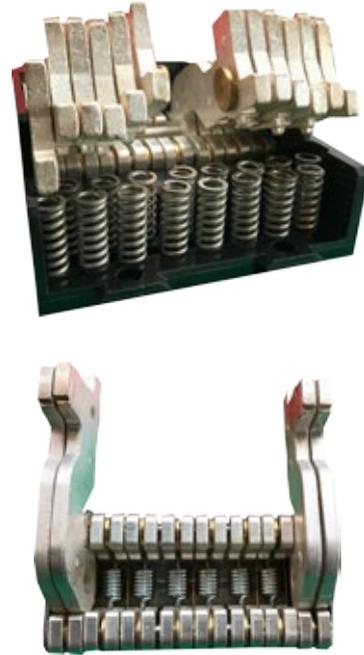
Figure 3 - Internal springs from clusters

All draw-out switchgear such as an ACB utilise isolator clusters which can be subject to contact corrosion. During a fault condition, the electrical current passes from the connections, through the clusters, then contacts. The isolating clusters are spring loaded and are therefore subject to some degree of slight arcing that can lead to increased contact resistance and will eventually overheat (see Figure 3 below).

Often maintenance engineers will replace an existing draw out ACB body with a new body in order to resolve an overheating problem. Unfortunately, all too often they discover that the over temperature was not due to the contacts but actually due to a loss of spring tension in the isolating clusters, which traditionally are inaccessibly located inside the ACB chassis.

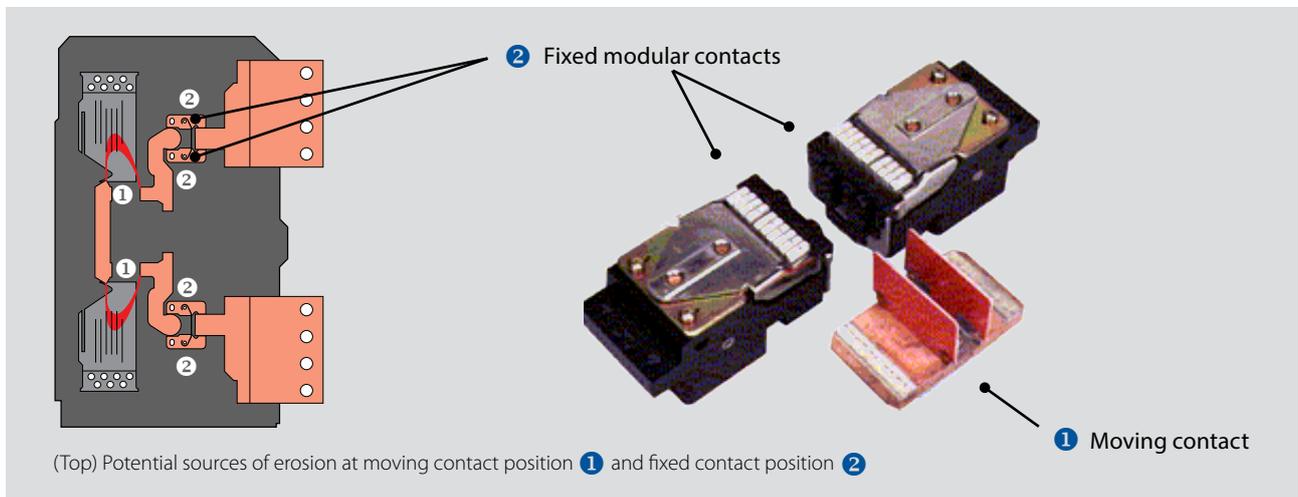
Figure 2 – Internal contacts of an ACB that can be damaged by continual arcing during switching

Depending on the application, over time the fixed and moving contacts of a circuit breaker or switch can be prone to contact erosion. Localised arcing and contact erosion can occur when switching an inductive load such as a motor. Over several cycles, this can lead to an uneven contact surface and contamination build up, thus increasing contact resistance shown in Figure 2.

(Top) Potential sources of erosion at moving contact position 1 and fixed contact position 2

If a circuit breaker has been subject to lower magnitude faults over its lifetime, i.e. ground faults, this too can result in an increase in temperature at the contact point, which will transfer to the terminals. Therefore, it is imperative that internal contacts, particularly of a main incoming ACB be of a modular design allowing for easy replacement.

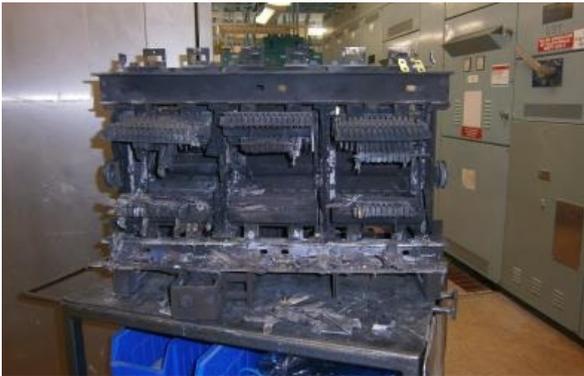
Figure 4 – Fire damaged ACB caused by an overheating cluster

See the example below in Figure 4, where a combination of poor maintenance procedures and a worn, overheated isolating cluster resulted in a major switchboard fire. This incident occurred at a Western Australian mining site in 2014, resulting in a costly interruption to production and the maintenance worker was badly injured. The official investigation noted that the circuit breaker's clusters had a history of reduced spring tension which lead to the hot joint.

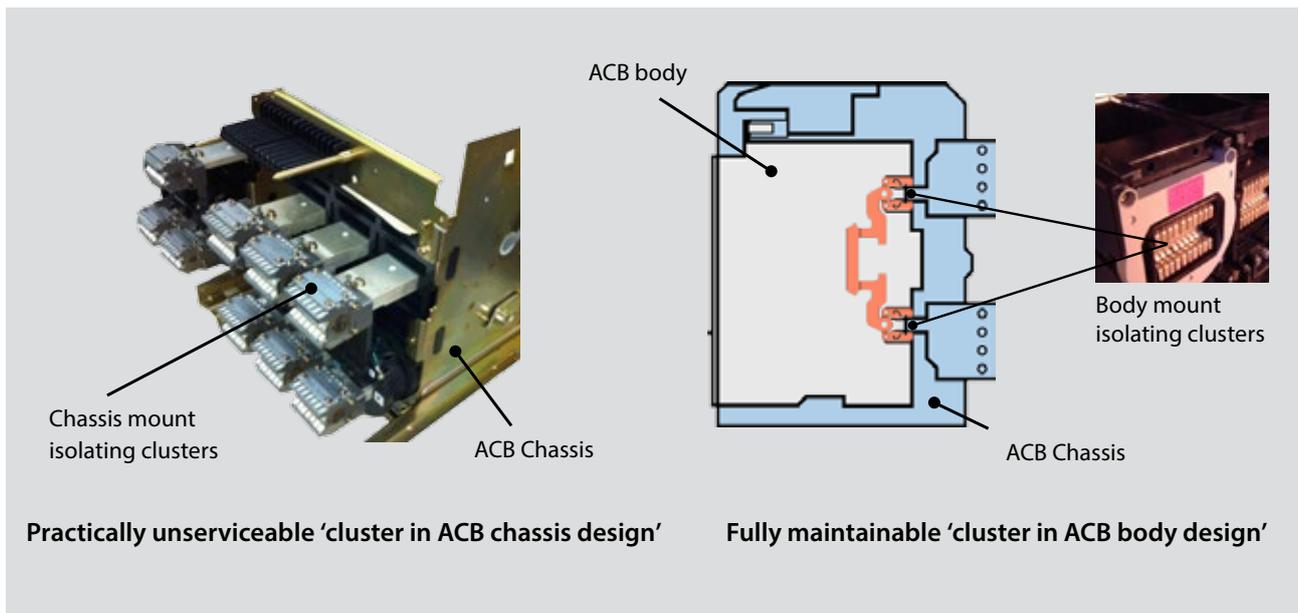
Figure 5 – Traditional 'cluster in ACB chassis design' vs the new modern 'cluster in ACB body design'.

Utilising drawout switchgear that contains the isolating clusters directly integrated into the 'removable body' ensures both the contacts and isolating clusters can be inspected and easily maintained. Figure 5 below, shows the traditional problematic 'cluster in ACB chassis design' compared to the modern, fully maintainable 'cluster in ACB body design'.

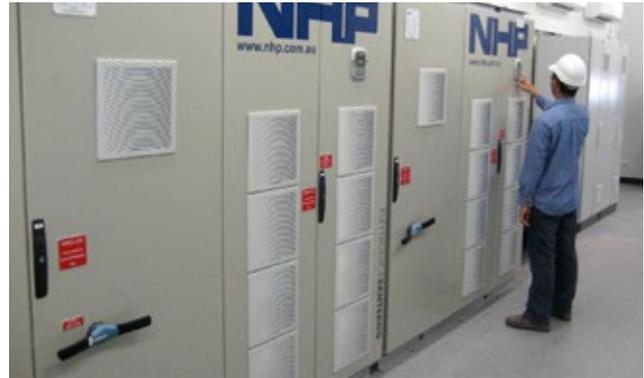
Some degree of ventilation is always provided for installed switchgear, having a rating of anything from IP31 to IP43. Several louvres in the switchboard facilitates a degree of air flow in the enclosures; however some designs with higher IP ratings may use fans to provide forced air cooling for switchgear equipment. In particularly dust prone environments (i.e. mining sites) these louvres can become 'clogged' with contaminants, leading to increased thermal stress on components. If left undetected this could result in eventual pre-mature failure of the switchgear.

*(above) Clean louvres allow optimum air flow*

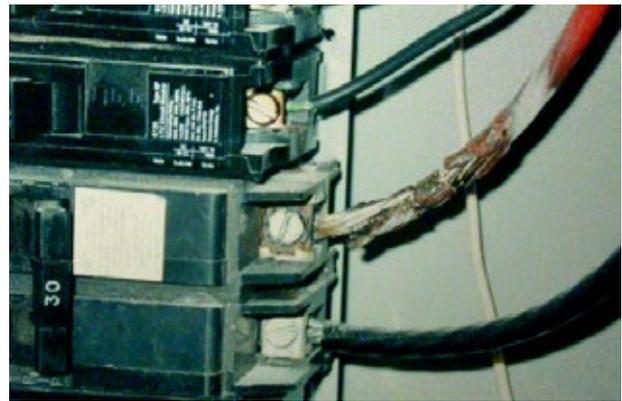
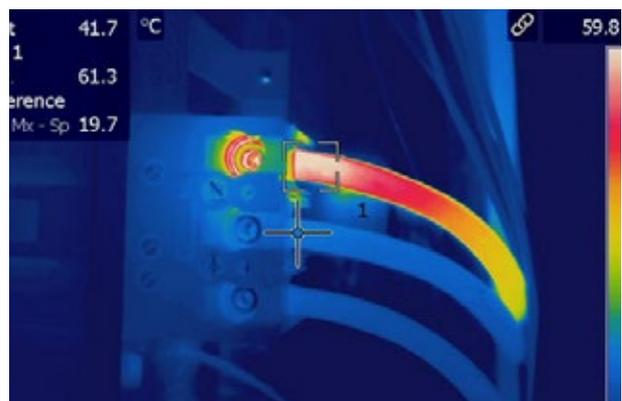
*Figure 6 - Infrared Thermography of a 'hot' cable termination*

Infrared scanning of electrical components can help detect loose connections and defective equipment as part of a preventative maintenance regime as shown in Figure 6.

In this picture the MCCBs outer phase is generating excessive heat due to the poor cable connection.

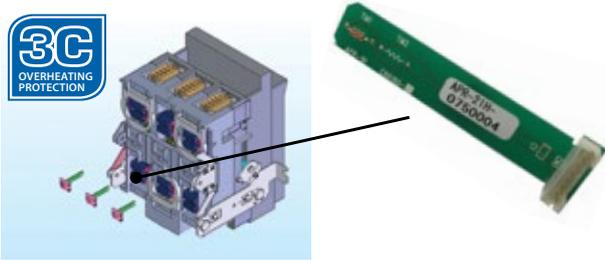
Figure 7 - ACB with integrated thermal sensors

NHP are proud to bring a system unique to Terasaki ACBs that provides condition based temperature monitoring as an option. This fully integrated temperature condition monitoring system continually checks for overheating abnormalities that could be due to an issue with the main Conductors, Contacts and Connections as show below in Figure 7.

The status and wear of the contacts is determined by the temperature measurement using NTC (Negative Temperature Co-efficient) thermistors. Self-diagnosis is achieved by direct measurement of physical properties. Each phase of the circuit breaker contact is fitted with its own thermistor. The thermistor will analyse all the three phases continuously every ten milliseconds.

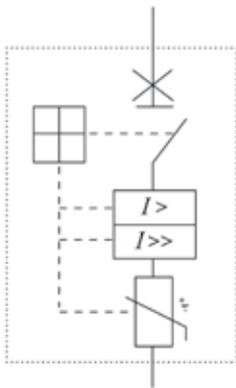
Figure 8 – Electrical symbol indicating a circuit breaker with integrated overload, short circuit and 3C protection.

Within the European electrical industry, the Conductors, Contacts and Connections temperature monitoring concept is abbreviated to '3C' and circuit breakers that offer this level of protection are usually represented by the electrical symbol shown in Figure 8.

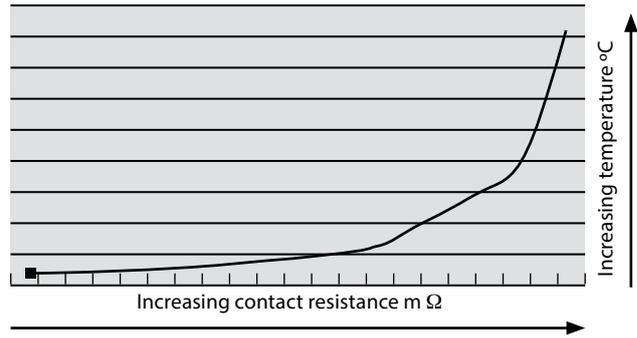
Figure 9 - ACB Contact Temperature vs Resistance

The thermistors used are in a glass encapsulated package, diode outline, with axial tinned Dumet (Copper-Clad Ni-Fe) wire. An example of temperature response to contact resistance (wear) for ACB contact temperature monitoring is shown in Figure 9.

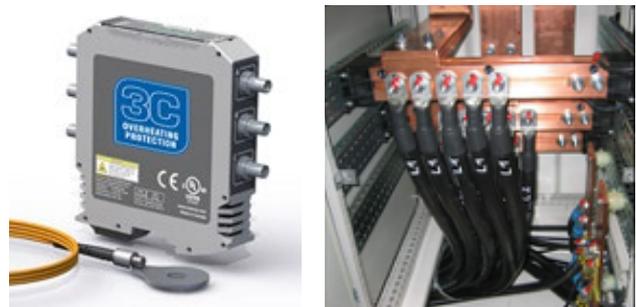
Figure 10 - External 3C module for busbar zone monitoring

To compliment the integrated circuit breaker over temperature protection and extend the level of monitoring to other areas of the switchboard, such as busbar zones, external 3C modules can be used. These external modules use non conductive fibre optics probes which can be fixed directly to a busbar via a special terminating lug.

The temperature is measured by pulsing a laser down the fibre optic cable to a phosphor dot located on the terminating lug. The phosphor dot is excited by the laser and starts to glow. The module then measures how long the phosphor glows (which is linked to the temperature) and then calculates the temperature which can be communicated over the network (see below in Figure 10).

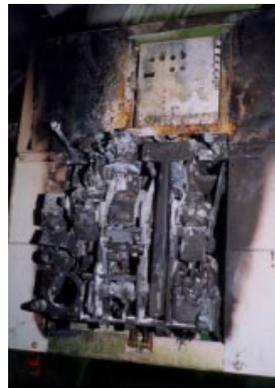
The fire destroyed the switchboards' main ACB and its associated control equipment.

Furthermore heat damage had affected the adjacent cubicles in the switchboard resulting in the synchronising panel being rendered inoperative. The remainder of the main switchboard had suffered some smoke damage. Contractors carried out repairs over the next 18 days during which all the ship's circuit breakers were replaced with a Lloyd's approved type.

*(above) Damaged switchboard from the Goliath*

- The source of fire was an internal fault in the generator ACB, a likely result of serious overheating of the centre pole conducting path.
- A previous infra-red examination carried out in Melbourne to detect hot spots on the ship's switchboards, had found no defects.
- Manufacturer recommended maintenance inspections had never been carried out on the ships ACBs.
- A heat detector, located close to the ACB cubicle failed to alarm due to the switchboards' design and layout.

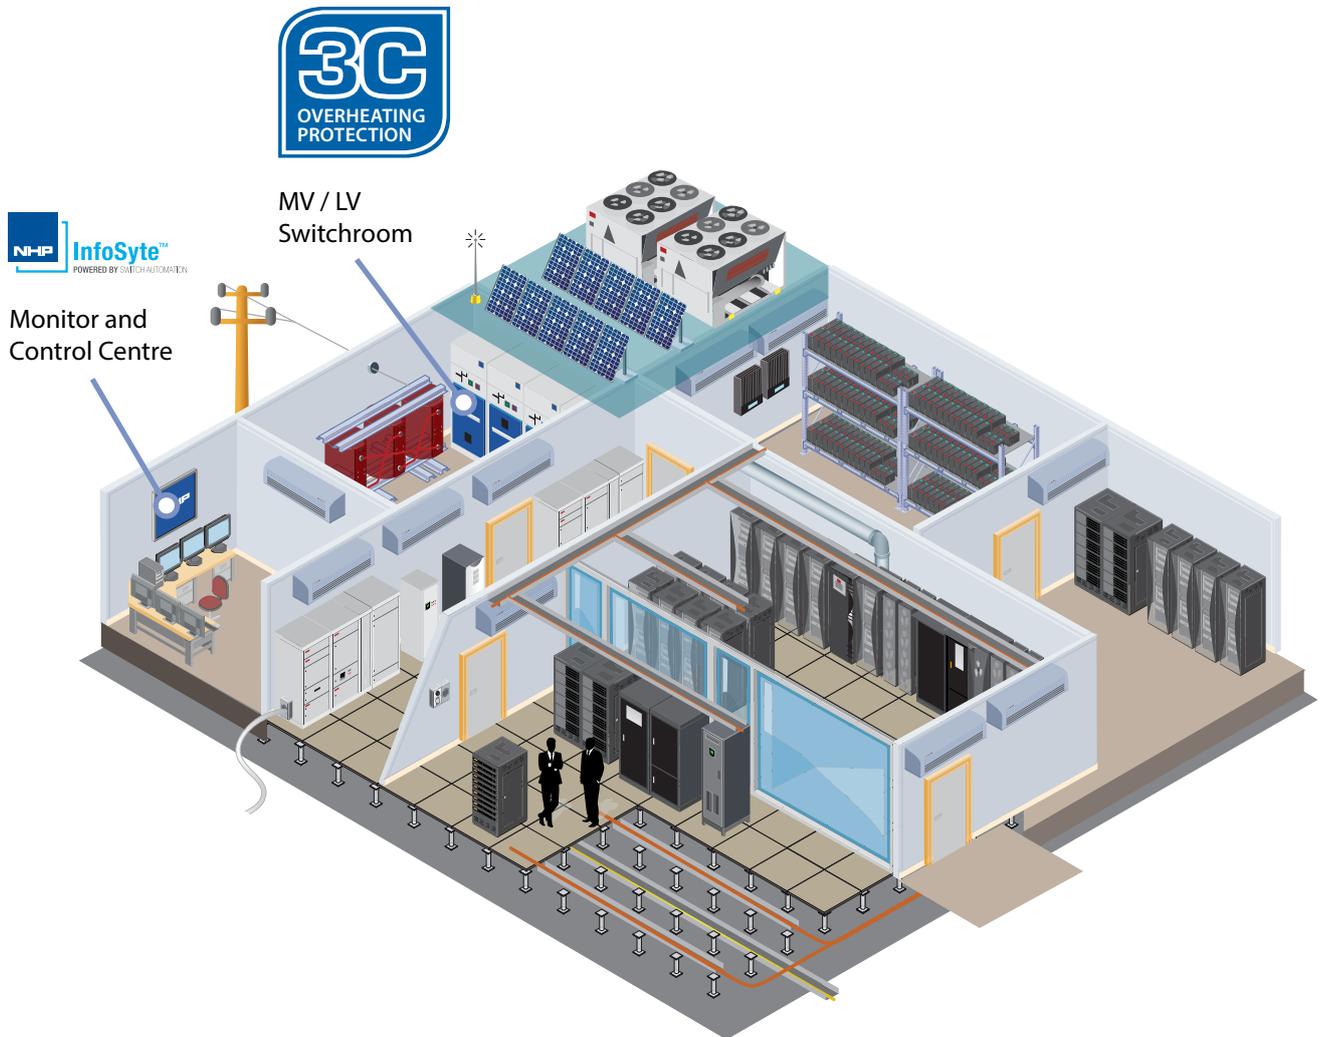
Figure 11 – Example data centre with 3C integrated protection circuit breakers being monitored by the InfoSyte software platform

In this example the focus will be on the MV/LV switchroom and the Monitor and Control Centre (see Figure 11).

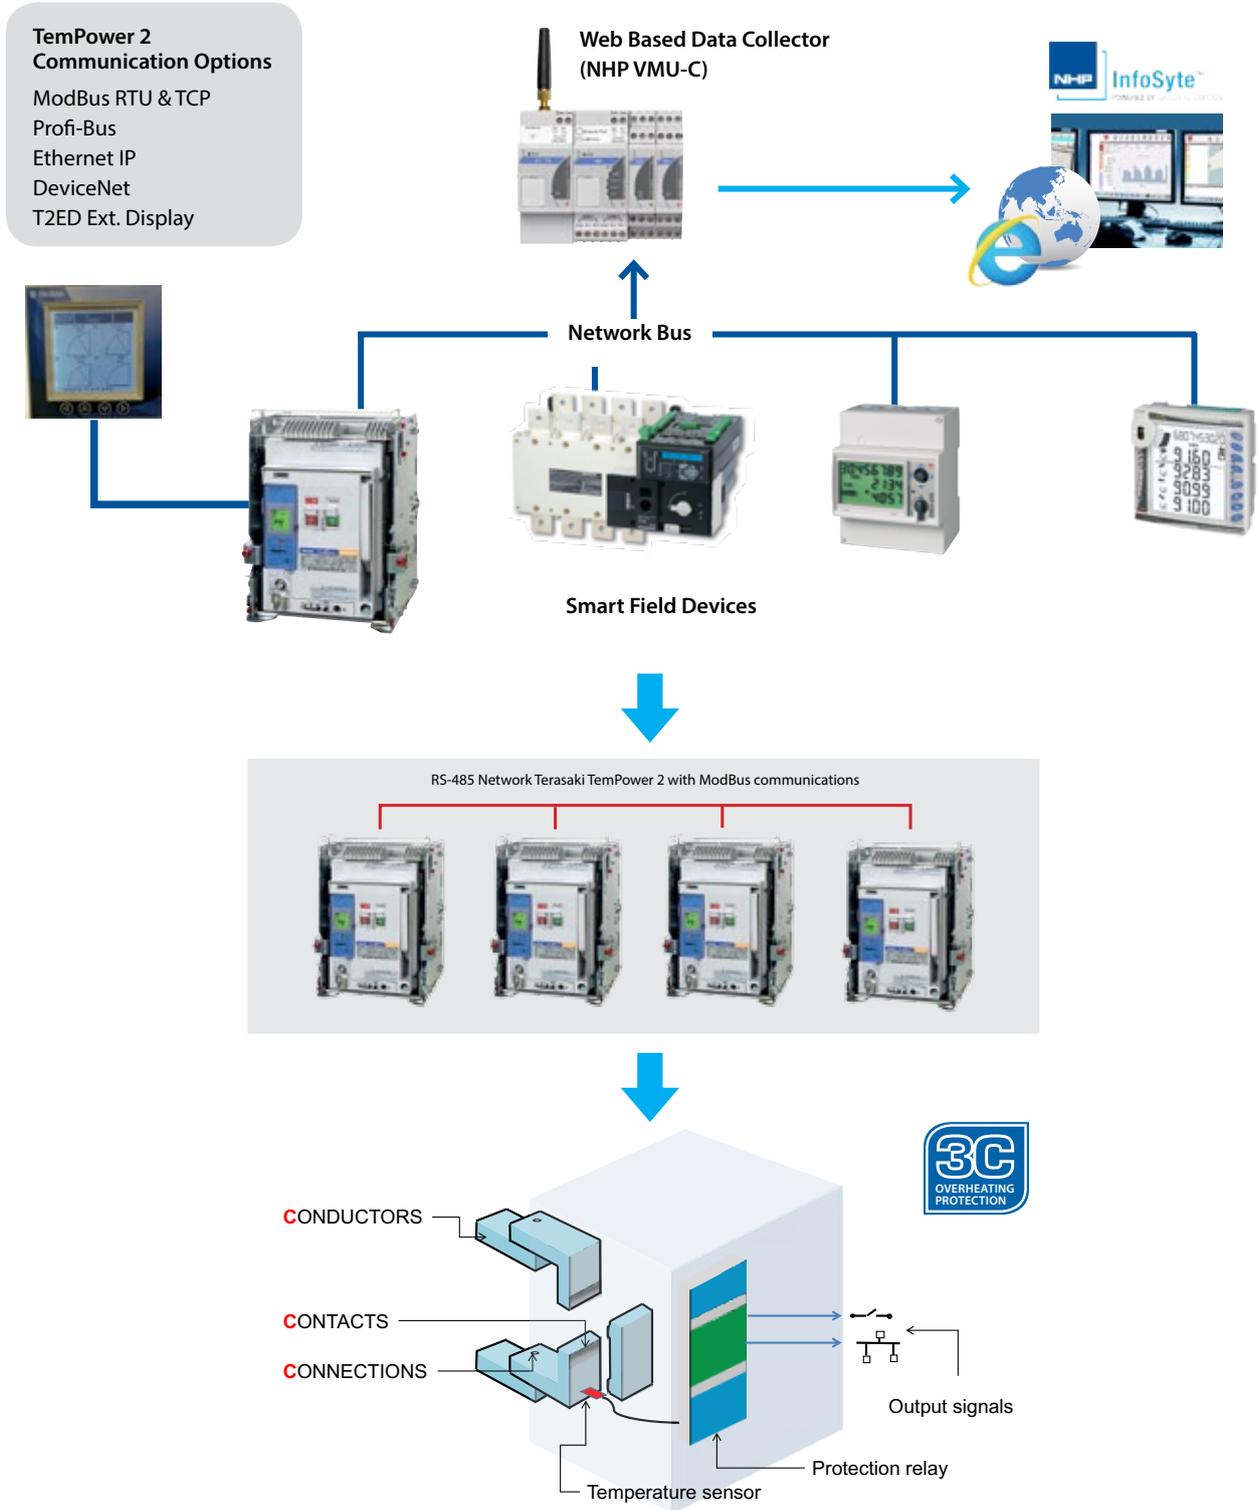
Figure 12 – Smart devices which are monitored over the data network via NHP InfoSyte, and all ACB's in the switchboard are 3C overheating protection enabled

In this scenario, all 'smart devices' are communicating on the data network and are monitored for status and alarms by the NHP InfoSyte software platform (see Figure 12 below). The ACBs contain integrated 3C overheating protection, therefore contact overheating can be detected by the ACBs trip unit.

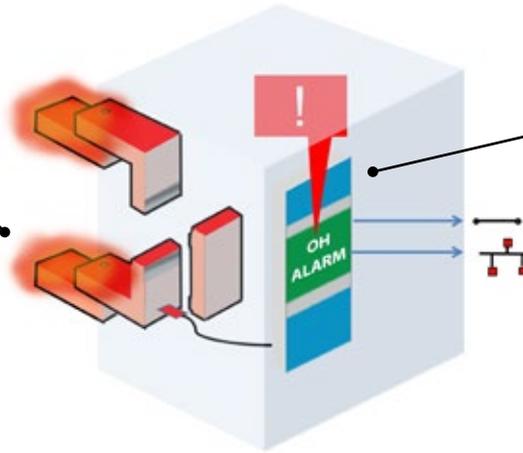
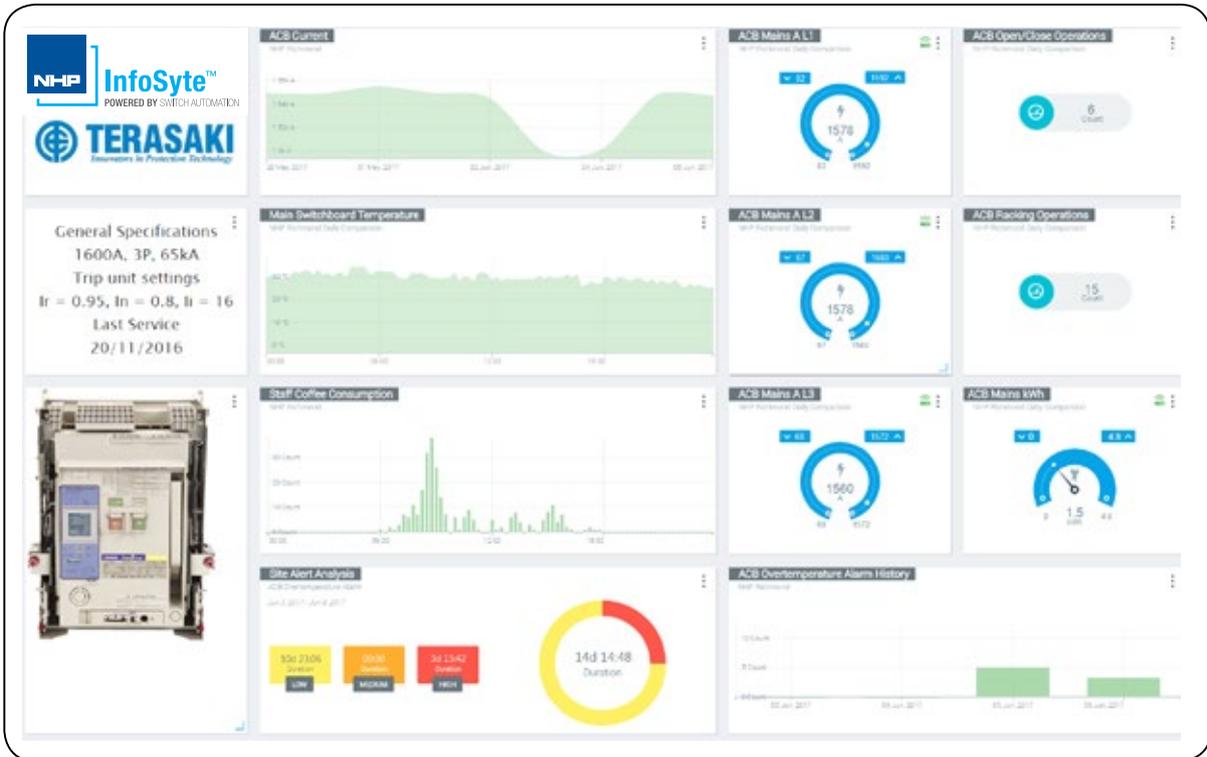
Figure 13 – Example contact overheating notification report via NHP InfoSyte

3C overheating protection detects the abnormal temperature within the contact set and activates the alarm (both relay contact and via the data communications network) as per Figure 13.

OH Alarm ACTIVE – Monitoring and Control Centre notified via InfoSyte system. ACB details such as past trip and alarm history could be displayed as well.

The ACB trip unit can be configured by the site engineer to 'trip' the ACB of just 'Alarm' (i.e. no trip, just notification) if overheating occurs, avoiding the stoppage of any critical processes.

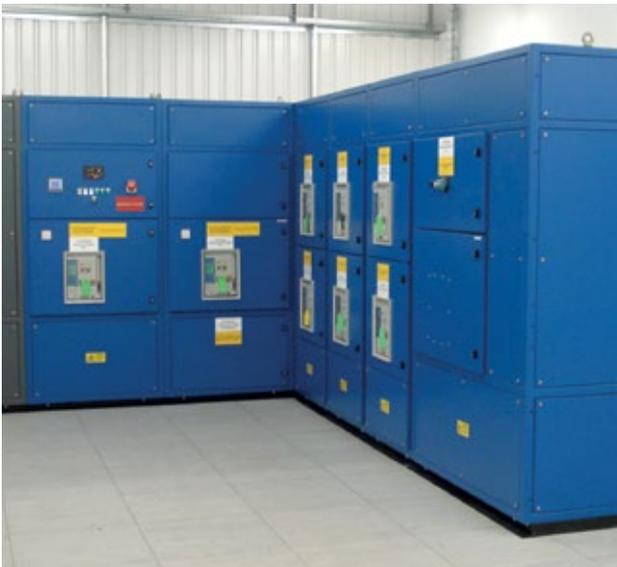
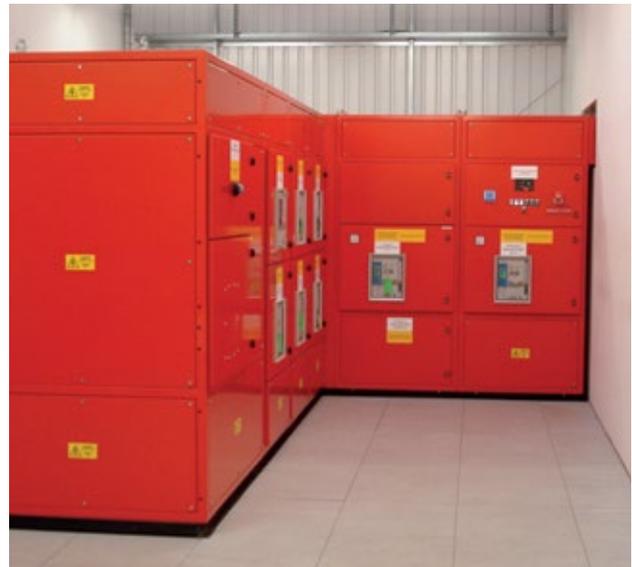
Figure 14 – Switchboards installed into the 12MW data centre which incorporated 3C overheating protection

The Rosebery Group used Terasaki's 3C overheating protection in the switchboards for the 12 megawatt data centre (pictured below). The following Terasaki products were used:
